Vol. IV

No. 322

REPORT OF STATIC TEST OF SKI FOR AN SE-5 AIRPLANE

Prepared by Engineering Division, Air Service
McCook Field, Dayton, Ohio
October 3, 1921

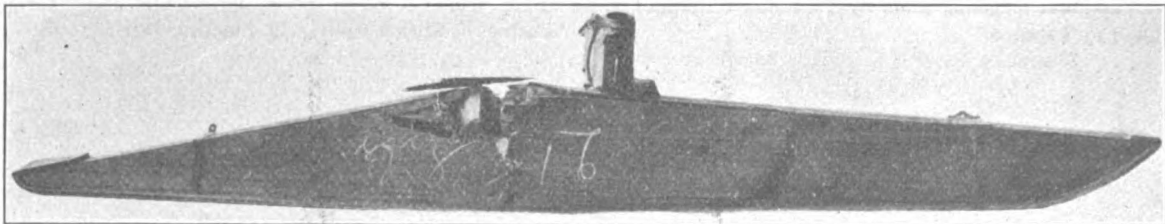
FIG. 2.

Failure occurred with a load of 12,500 pounds. Figure 2 shows the resulting failure.

Before failure it supported six times the total weight of an SE-5 airplane, or 12 times the load upon it when the airplane is at rest.

The results obtained are satisfactory. The ski is strong enough to be in service for a while under various weather conditions and still function satisfactorily.
